Manhole Inspection Summary

Manhole # S29EE2004MH

Insp Date: **12/6/06 2:51 PM**

Location Address: **5711 CHARLES ST**

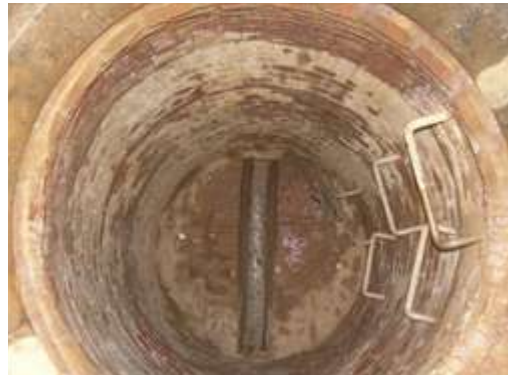
Top View

Bench ☒ Exists Material: **Brick** ☐ Parged ☒ **Debris** (not Condition related)

Bench debris.

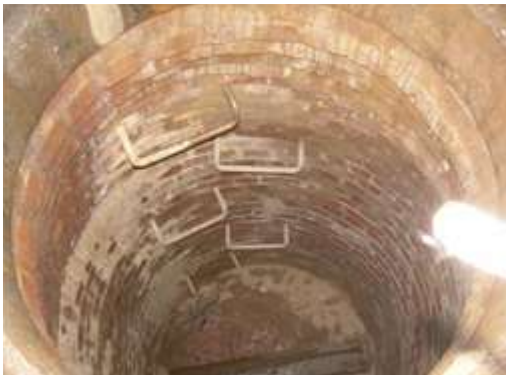
Defect

Frame Offset: **0** (in.) Condition: ☐ Sound ☐ Cracked ☒ **Leaks**

Infiltration: ☐ None ☒ **Joint** ☐ Cracks ☒ **Mortar** ☐ Roots ☒ **Wall**

Infiltration: ☐ None ☐ Joint ☐ Cracks ☒ **Mortar** ☐ Roots ☒ **Wall**

Frame leaks. Adjustment, Corbel and Barrel infiltration - other side.

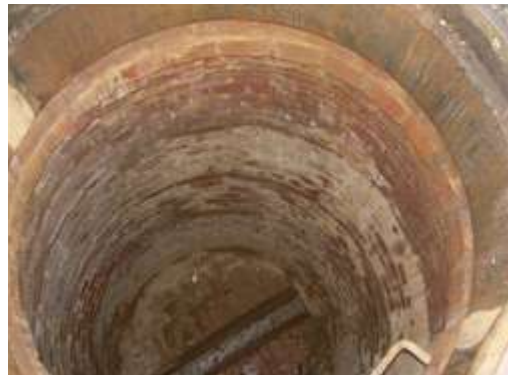
Defect

Frame leaks. Adjustment, Corbel and Barrel infiltration.

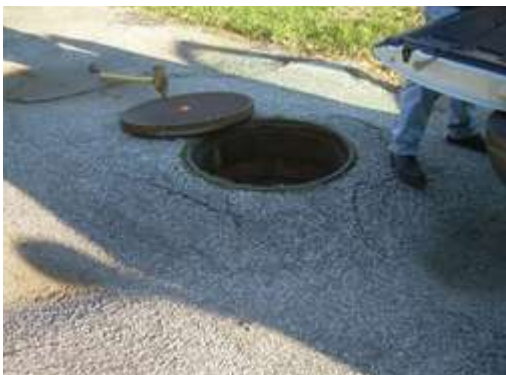
Defect

Comments **The pavement around the MH is sinking.**

Sinking pavement.

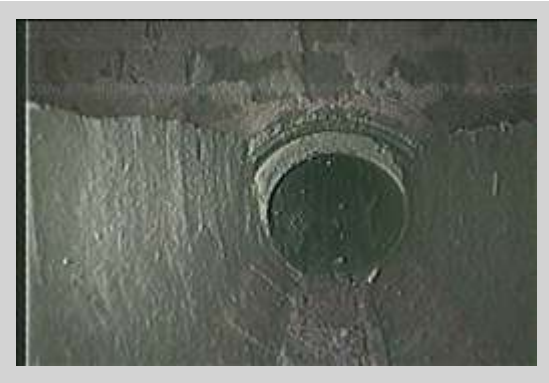
Pipe Out @ 12 O'Clock

Infiltration: **Evidence** Pipe Seal Cond: **Unknown**

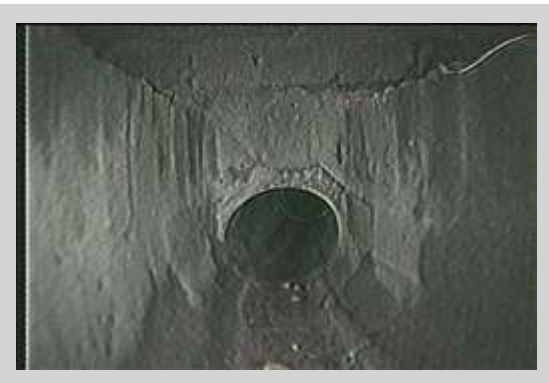
Pipe In @ 6 O'Clock

Infiltration: **Evidence** Pipe Seal Cond: **Unknown**
